EUTECTIC COMPOSITE TURBINE BLADE DEVELOPMENT

AIRCRAFT ENGINE GROUP, GE
CINCINNATI, OHIO 45215

TECHNICAL REPORT AFML-TR-76-191

Final Report for Period 1 April 1973-30 November 1976

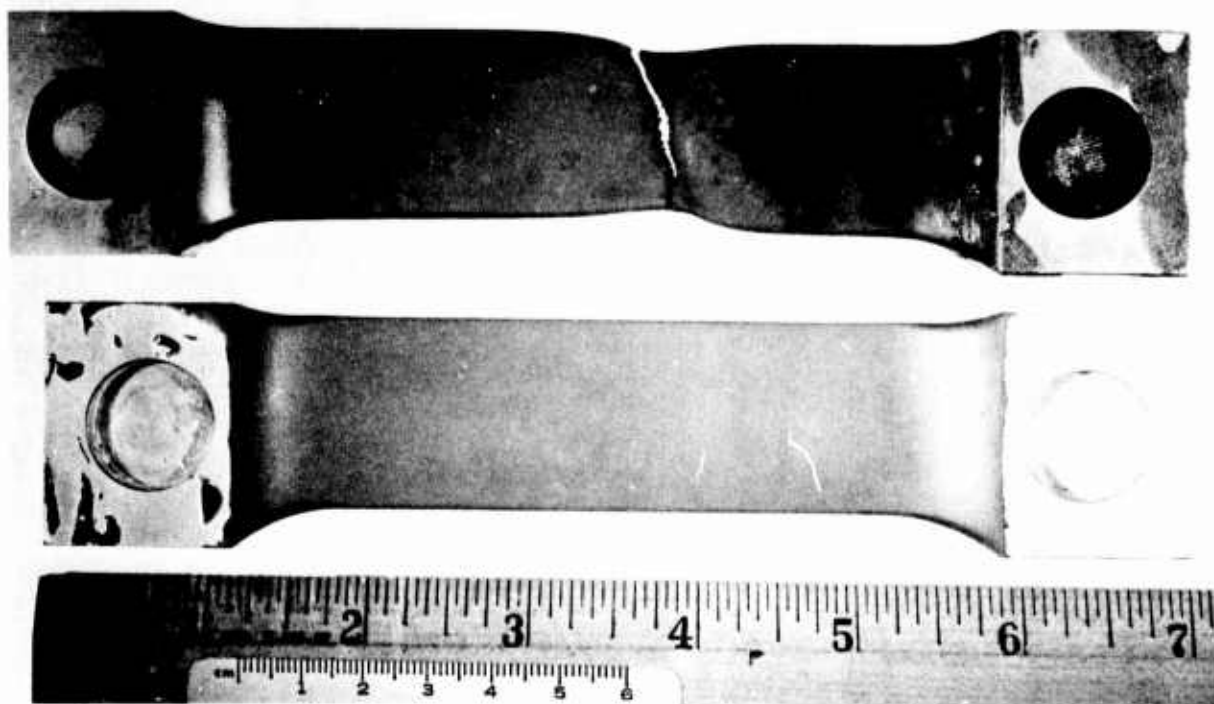
Figure 140. Flame Tunnel Test Specimen 3B59 Before Test and After Fracture
